Manhole Inspection Summary

Manhole # S2111_003MH

Insp Date: **5/13/08 9:56 AM**

Location Address: **2700 wegworth la**

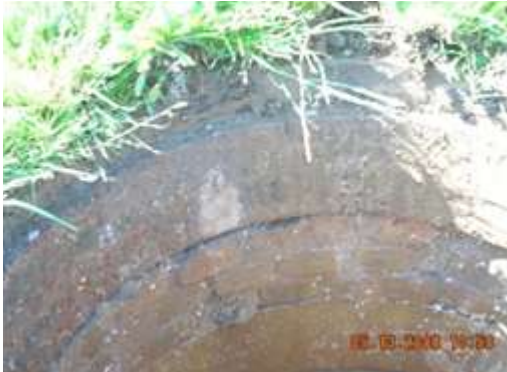
Defect 3

☒ **Leaks**

inflow evidence

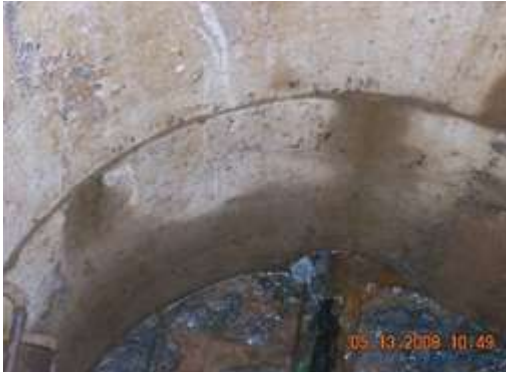
Defect 2

Infiltration: ☐ None ☒ **Joint** ☐ Cracks ☐ Mortar ☐ Roots ☐ Wall

infiltration @ barrel/corbel joint

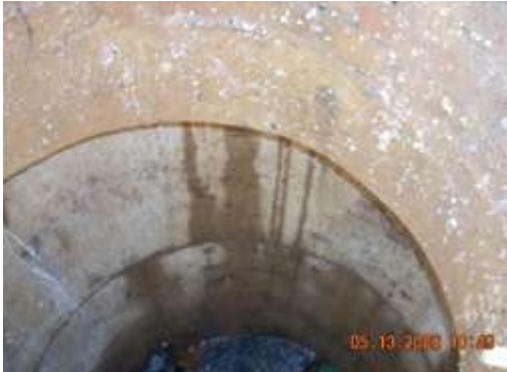
Defect 1

Infiltration: ☐ None ☒ **Joint** ☐ Cracks ☐ Mortar ☐ Roots ☐ Wall

infiltration @ chimney/corbel joint

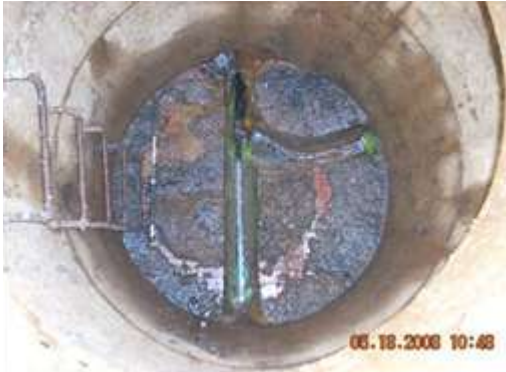
Defect 4

Condition: ☐ Sound ☐ Cracked ☐ Root Intrusion ☐ Deteriorated ☐ Leaks ☒ **Debris**

Bench Debris

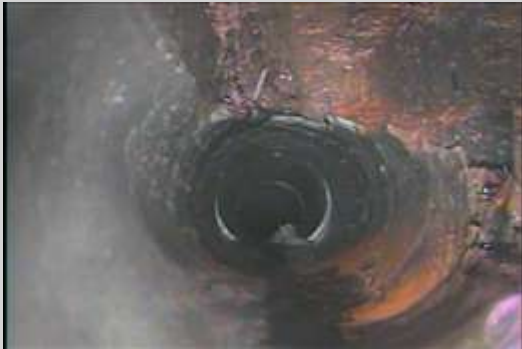
12 O'Clock Outflow

6 in. Circular Gravity Sewer
Pipe Out @ 12 O'Clock

Pipe Height: **6** (in.) Rod and Bar (Angled)
Pipe Material: **PVC** ☐ Pipe Lined
Invert Depth: **8.93** (ft.) Flow Characteristics: **Slow**
Deposits: ☒ None ☐ Mud ☐ Sludge ☐ Debris ☐ Grease
Silt Depth: **0** (in.) Deposits Extent:
Infiltration: **Evidence** Pipe Seal Cond: **Unknown**
